## EDGEFIELD GOLF COURSE - Stormwater Swale Repair

### + **Project Snapshot**

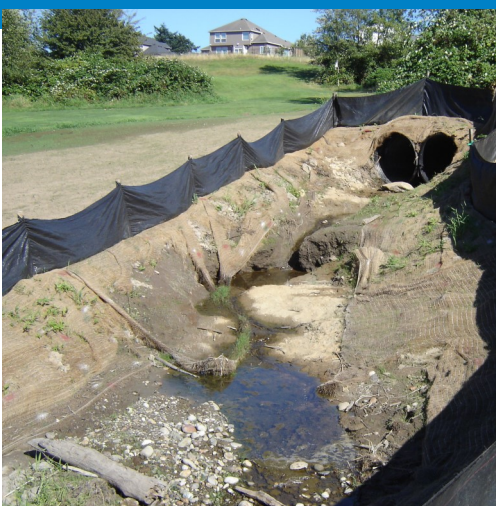
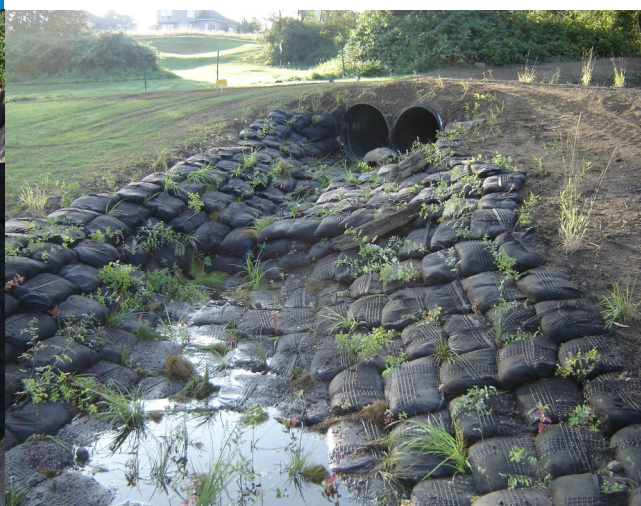
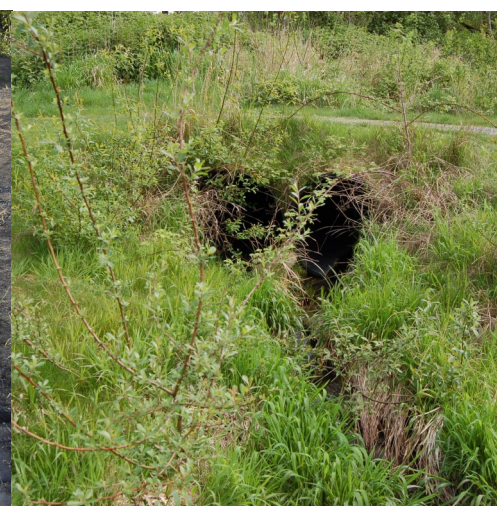
A residential subdivision development upstream of a stormwater swale increased impervious surface runoff causing severe scouring of more than four feet in a drainage ditch. The severe scouring was discovered after the removal of invasive vegetation and water runoff was leading to sediment discharge in the wetlands below. Envirolok's patented system was used to build a "mattress" of units that encapsulated the soil, prevented erosion, and served as a medium to vegetate the swale. The forces that caused the scouring were eliminated due to the durable Envirolok fabric acting as a splash guard. The ability of the Envirolok system to withstand flashy storm events solved a persistent and costly erosion issue. Native plants were planted upon completion of construction, replacing their invasive counterparts. Through the Envirolok system and native vegetation, storm event erosion is non-existent, and the ecosystem is growing native species, adding new habitat to the golf course.
